### **Volunteer Fire Fighter Dies after Coming into Contact With a Downed Power Line - Arkansas**

#### **SUMMARY**

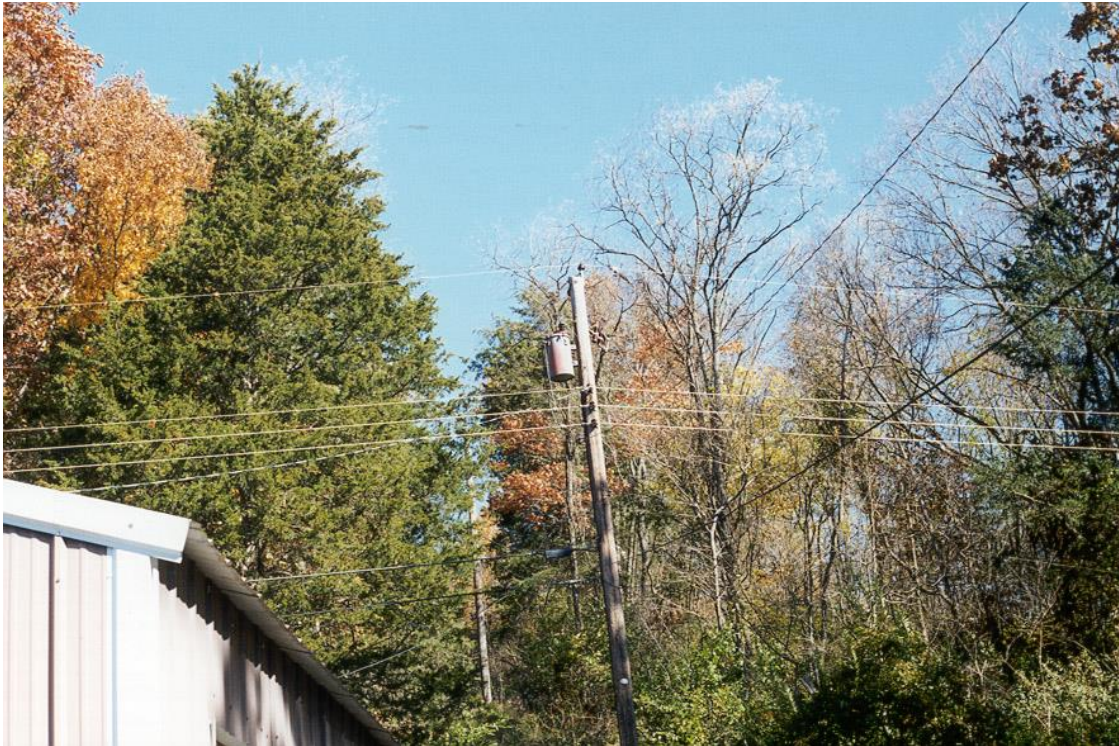
*Incident Site*

Discussion: As stated in the Fundamentals of Wildland Fire Fighting, when downed power lines come in contact with the ground, current flows outward in all directions from the point of contact (ground gradient). The energized area can extend several feet from the point of contact; therefore, fire fighters could be electrocuted by walking into this area (Step Potential). To avoid this hazard, fire fighters should keep an ample distance away from the downed power line (equal to one span between poles) until the power is de-energized. If, upon arrival, the fire has not burned past the distance equal to one span between poles, fire departments should delay their attack until the fire has burned past this recommended span. Based upon past experiences involving this utility easement and downed power lines within their area, the fire fighters believed that the fire may have been caused by a downed power line. However, not seeing a downed power line during the initial size-up or during subsequent searches, the fire fighters believed the brush fire was started by hot embers falling from the tree that was leaning against the three power lines. The single-phase, 7,200-volt line—gray in color and fairly small diameter—blended with the dead brush and leaves found at the incident site (see Photo #1 below). The occurrence of the incident at night also made it difficult to see.

***Recommendation #1: Fire departments should ensure that fire fighters are kept away from downed power lines at a distance equal to at least one span between poles until the line is de-energized.***<sup>1,2</sup>

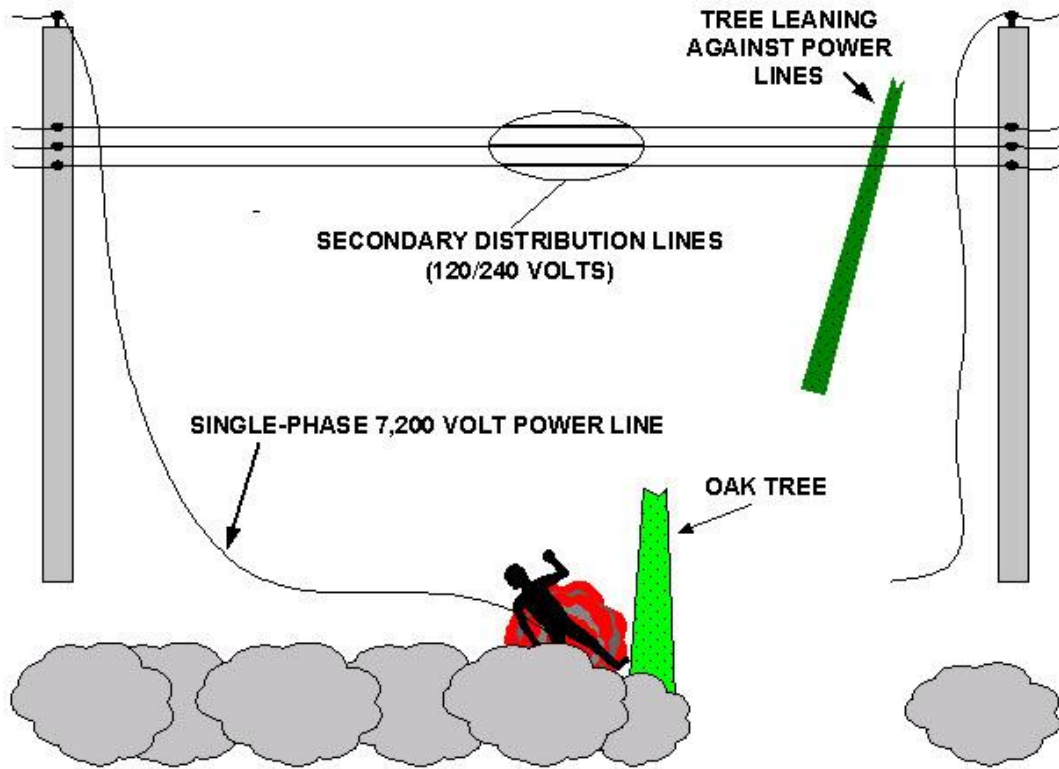
*Diagram 1. Profile of Incident Site*

On November 3, 1999, an 18-year-old male, volunteer fire fighter (the victim) was killed after coming into contact with a downed, single-phase, 7,200-volt power line. At 0400 hours a call came into Central Dispatch reporting a brush fire. A Captain, Lieutenant, and a fire fighter responded to the scene in privately owned vehicles (POVs). The Captain was first to arrive on the scene at approximately 0405 hours and noticed a small fire located behind a house in a utility easement, approximately 60 yards north of the road. The power poles within the utility easement have the following lines: a single-phase, 7,200-volt power line (that runs along the top of the poles) that is gray in color and very small in diameter (see Diagram 1 and Photo1), three 120/240-volt power lines installed on the poles directly below the 7,200-volt line (see Diagram 1), and cable and telephone lines installed below the 120/240-volt power lines. (Note: cable and telephone lines are not shown on Diagram 1.)

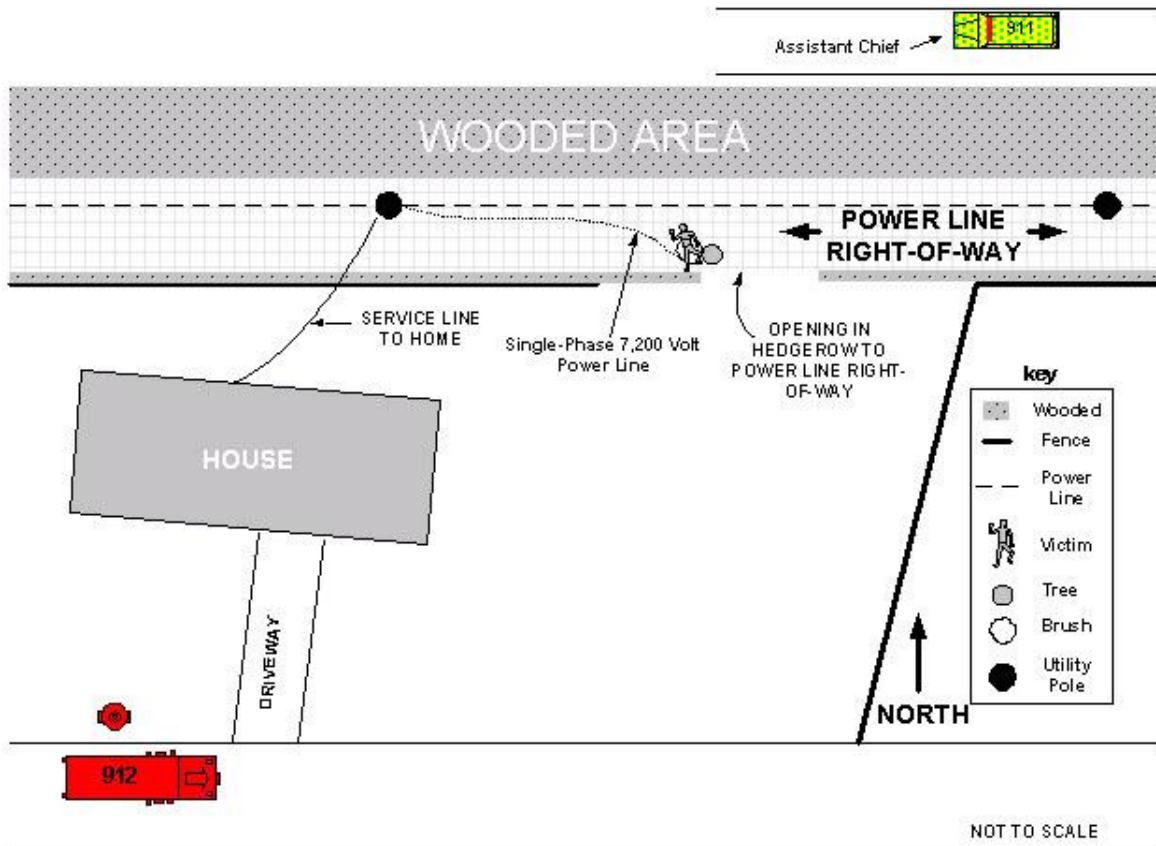
*Diagram 2. Aerial View of Incident Site*

The utility easement runs through the edge of a wooded lot, parallel to the roadway, and behind a residential area (see Diagram 2). The Captain proceeded toward the easement to conduct an initial size-up of the scene and noticed to the east a small-diameter tree leaning against the overhead power lines. To the west, he noticed a small, smoldering fire in the brush. The Captain reported to the Chief that it was a small electrical fire. The Captain believed that a power line was down because the fire department had responded in the past to brush fires in the area that had involved downed power lines. With only the aid of a flashlight, he was unable to see any downed power lines. The victim responded to the scene at 0410 hours with the Assistant Chief in Brush Truck 911 while the Chief responded in Engine 912. As the Captain returned to his vehicle, the Lieutenant and a fire fighter arrived on the scene in their POVs. Within 2 minutes of their arrival, the victim and the Assistant Chief in Brush Truck 911 and the Chief in Engine 912 arrived on the scene. The Assistant Chief drove the Brush Truck to a road north of the scene in an attempt to locate any other fires (see Diagram 2).
